This 126,300 SF, 2-story industrial building at the east side of Philadelphia Navy Yard houses Wuxi AppTec's United States Headquarters and its Early phase clinical manufacturing and testing facility. It was completed in 2016.

Highlights: Geotechnical Investigation; Surcharging with wick drains; settlement monitoring and instrumentation; post-surcharge verification

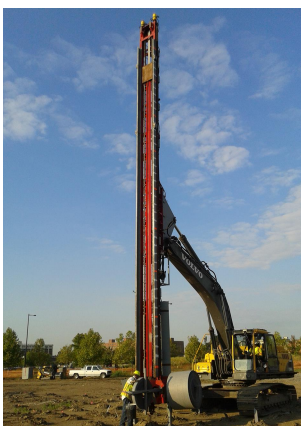
Wick Drains Installation

The ground improvement consists of **surcharging and strip (wick) drains**. The design was **optimized** considering the **cost of the additional fill** needed to construct a higher surcharge embankment **versus the cost of installing wick drains** to achieve the desired waiting period. The optimum design consisted of constructing **10-ft high embankment with 6-ft spaced wick drains with 6-month waiting period**. The surcharge height was increased to 20 ft in order to effect the removal of settlement for a mechanical room that was conceived at later stage.

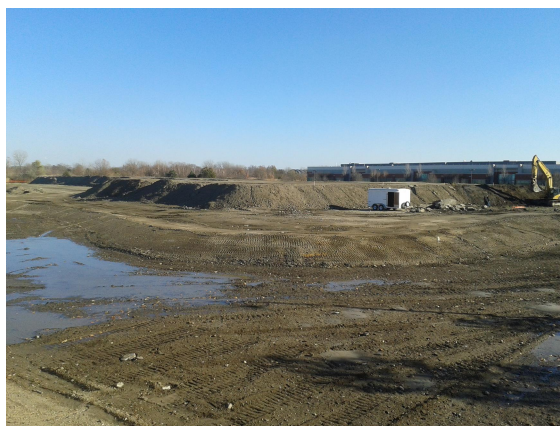
Overview of Surcharge Embankment

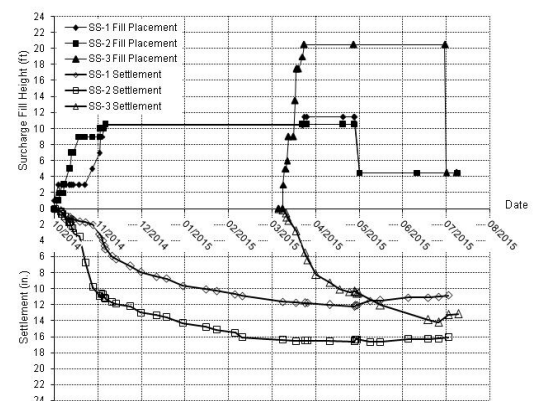
Surcharge Fill Height and Settlement vs time

Three **vibrating wire settlement sensors** and drive-point piezometers were installed **to monitor the settlement**. 50 to 75% of the total measured settlement had occurred while the surcharge is being placed. **Sensors settlement measurements matched the predicted one**. Post surcharge in-situ and laboratory testing showed a **3-fold improvement** in the preconsolidation pressure.
